Manhole Inspection Summary

Manhole # S21II_003MH

Insp Date: **6/25/07 9:21 AM**

Location Address: **1669 NORTH-WESTWOOD ALLEY** Cross Street: **WOODYEAR ST**

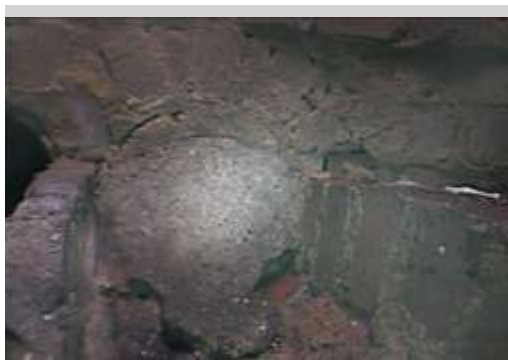
Comments **there are 2 pipes at i9, one of which is capped**

capped pipe at i9

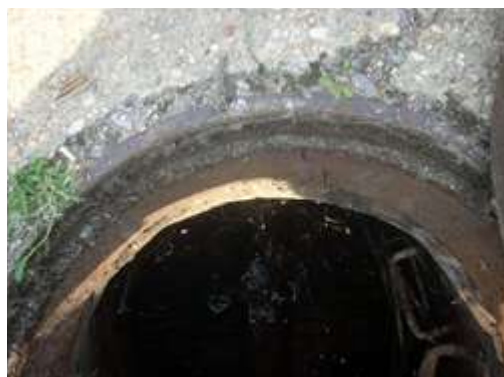
Defect 2

Frame Offset: **1** (in.) Condition: ☐ Sound ☒ **Cracked** ☐ Leaks

FRAME OFFSET

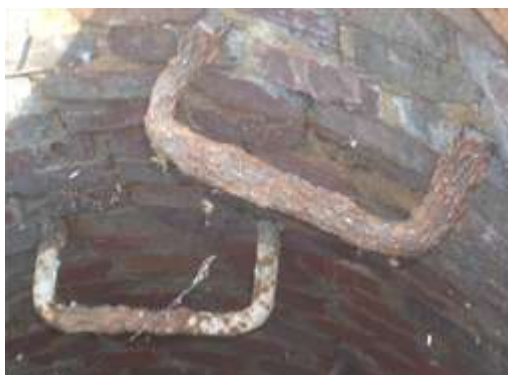
Defect 4

Steps Count: **4** Missing: **0** ☒ **Corroded**

CORRODED STEPS

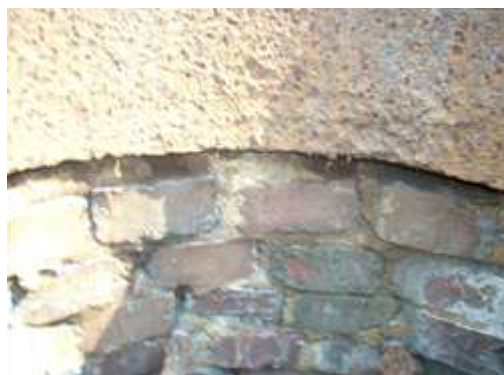
Defect 3

Corbel Material: **Brick** ☐ Parged Type: **Concentric/Eccentric**
Condition: ☐ Sound ☐ Cracked ☐ Root Intrusion ☐ Loose Brick ☒ **Deteriorated**
Infiltration: ☒ None ☐ Joint ☐ Cracks ☐ Mortar ☐ Roots ☐ Wall

DETERIORATION OF CORBEL

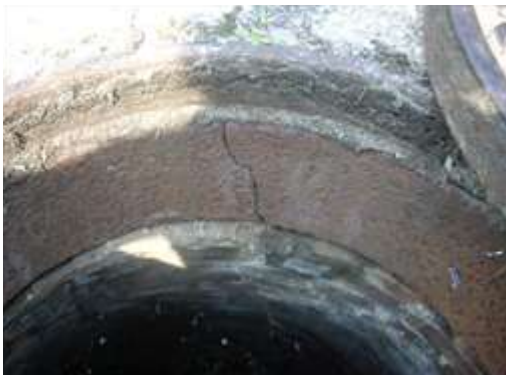
Defect 1

CRACKED FRAME

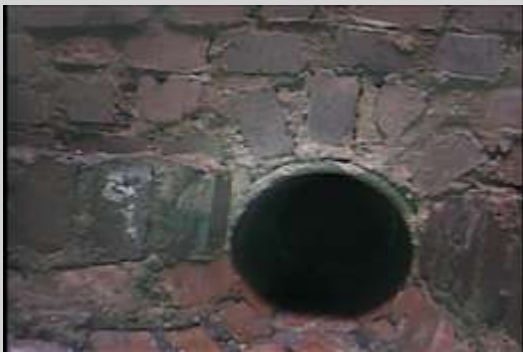
12 O'Clock Outflow

Pipe Height: **8.4** (in.) Rod and Bar (Angled)
Pipe Material: **Clay** ☐ Pipe Lined
Invert Depth: **7.83** (ft.) Flow Characteristics: **Slow**
Deposits: ☒ None ☐ Mud ☐ Sludge ☐ Debris ☐ Grease
Silt Depth: (in.) Deposits Extent:
Infiltration: **None** Pipe Seal Cond: **Broken**

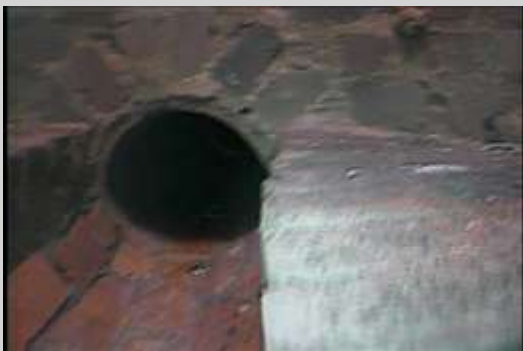
6 O'Clock Inflow

Pipe Height: **7.2** (in.) Rod and Bar (Angled)
Pipe Material: **Clay** ☐ Pipe Lined
Invert Depth: **7.75** (ft.) Flow Characteristics: **Slow**
Deposits: ☒ None ☐ Mud ☐ Sludge ☐ Debris ☐ Grease
Silt Depth: (in.) Deposits Extent:
Infiltration: **None** Pipe Seal Cond: **Broken**

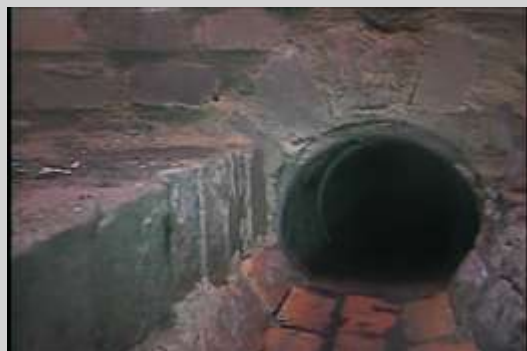
9 O'Clock Inflow

Pipe Seal Cond: **Broken**
